Initial Environmental Examination

Project Number: 55040-001

Bangladesh: Dhaka Power System Expansion and Strengthening Project

Audit Report for Existing Facilities

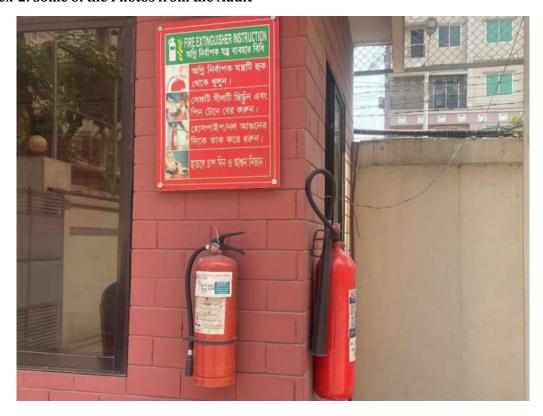
Photo 1: Fire extinguishers and instructions on use of them at Uttara 132/33/11 kV grid SS site

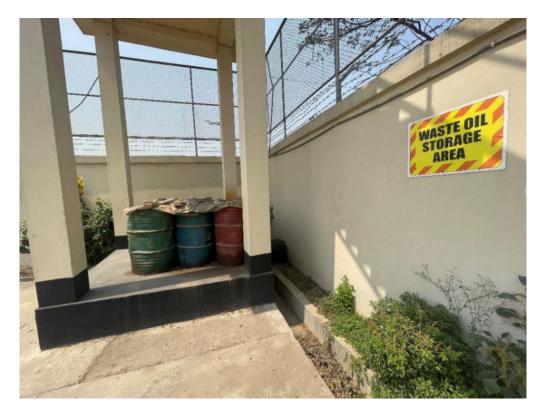
- II. A designated waste oil store area was found at the site premises but that was without any secondary containment. It is suggested that the waste oil store area be provided with a bund.

Photo-3 Waste oil stored without secondary containment at Uttara 132/33/11 kV grid SS site.

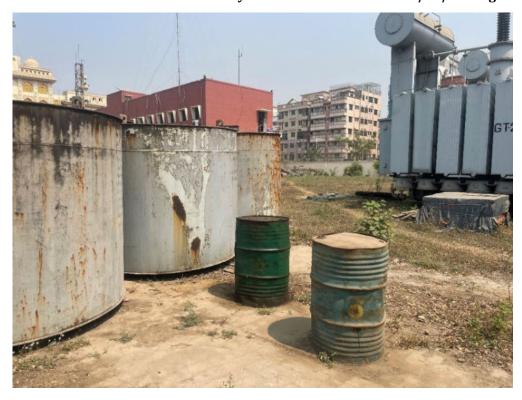
- III. Damaged transformers and waste oil of transformer in barrels were found kept on open ground. It is recommended that the damaged transformers and barrels of waste oil are stored in designated, impermeable bunded stores and at absolute minimum on drip trays rather than keeping them on open ground.

Photo-4: Damaged transformers and waste oil barrels store on open ground at Uttara $132/33/11\,\mathrm{kV}$ grid SS site.

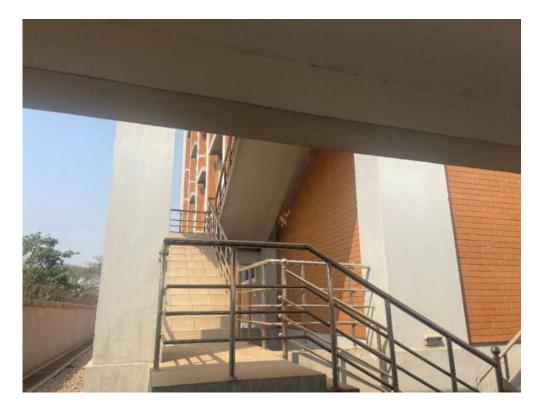
Photo-7: Emergency exit stairs at Purbachal S2 132/33/11 kV grid SS site

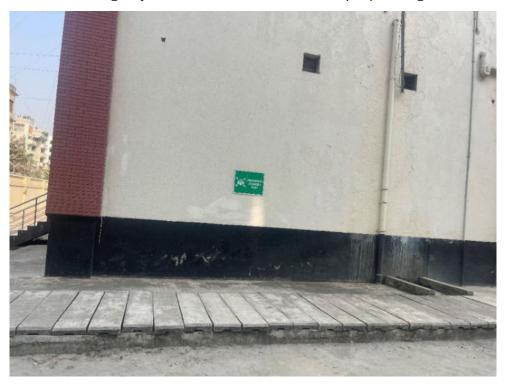
Photo-8: Emergency assembly point at Bashundhara D block 132/33/11 kV grid SS site

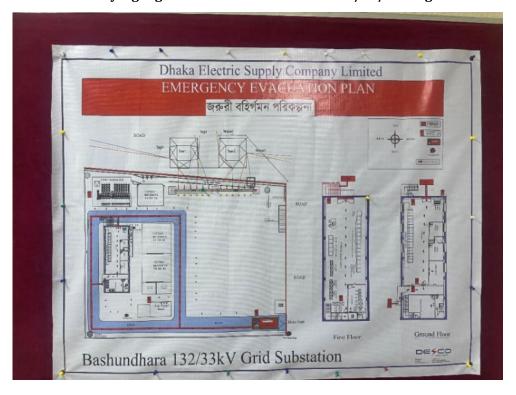
Photo-10: Emergency evacuation plan at Bashundhara D block 132/33/11 kV grid SS site

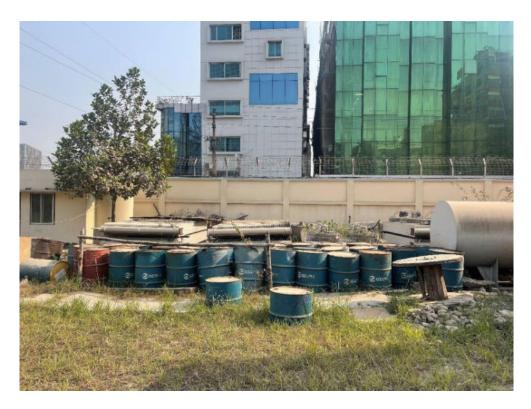
Photo-11: Damaged transformers and waste oil barrels stored on open ground at Bashundhara D block 132/33/11 kV grid SS site

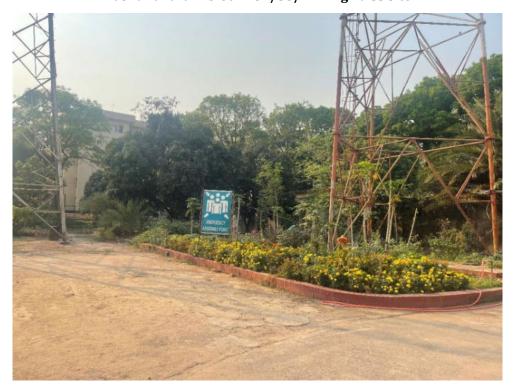
Photo-12: Emergency assembly point at Mirpur (Digun) 132/33 kV gird SS (PGCB) stie

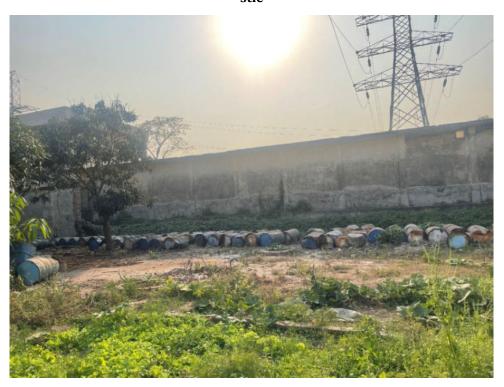
Photo-14: Waste oil barrels store on open ground at Mirpur (Digun) 132/33 kV gird SS (PGCB) stie

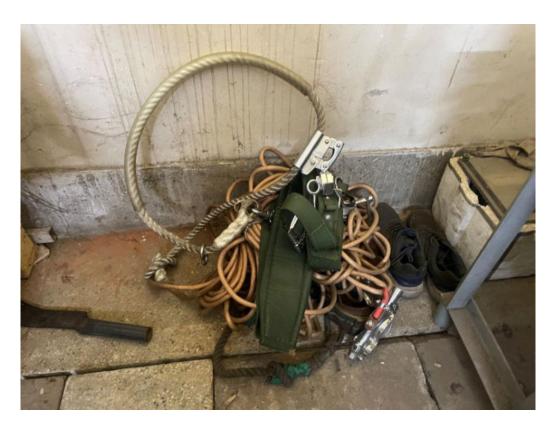
Photo-17: Improper stocking of PPE at Mirpur SS and same was in all other ither audited SS

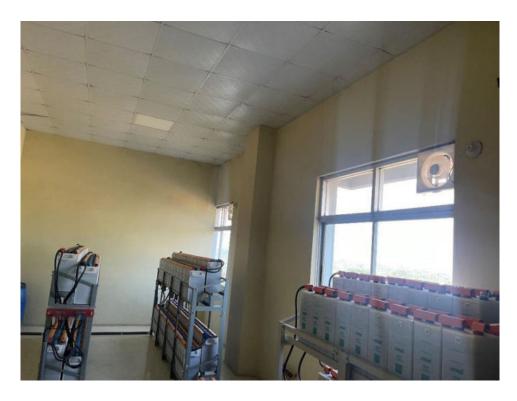
Photo-19: Exhaust fan for ventilation in battery room

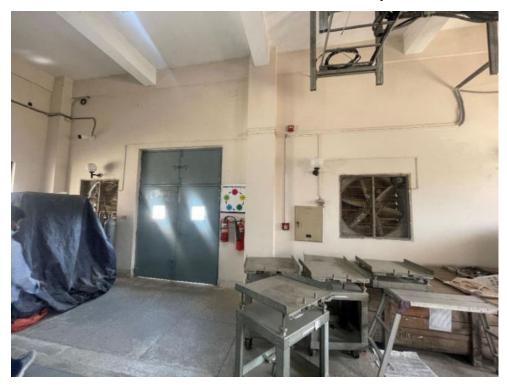
Photo-20: Exhaust fan for ventilation at Uttara SS and same was found in all other SS
